**Coal Combustion Residue Impoundment
Round 9 - Dam Assessment Report**

Cliffside Steam Station

Ash Basin Dikes

Duke Energy Corporation
Moorestown, North Carolina

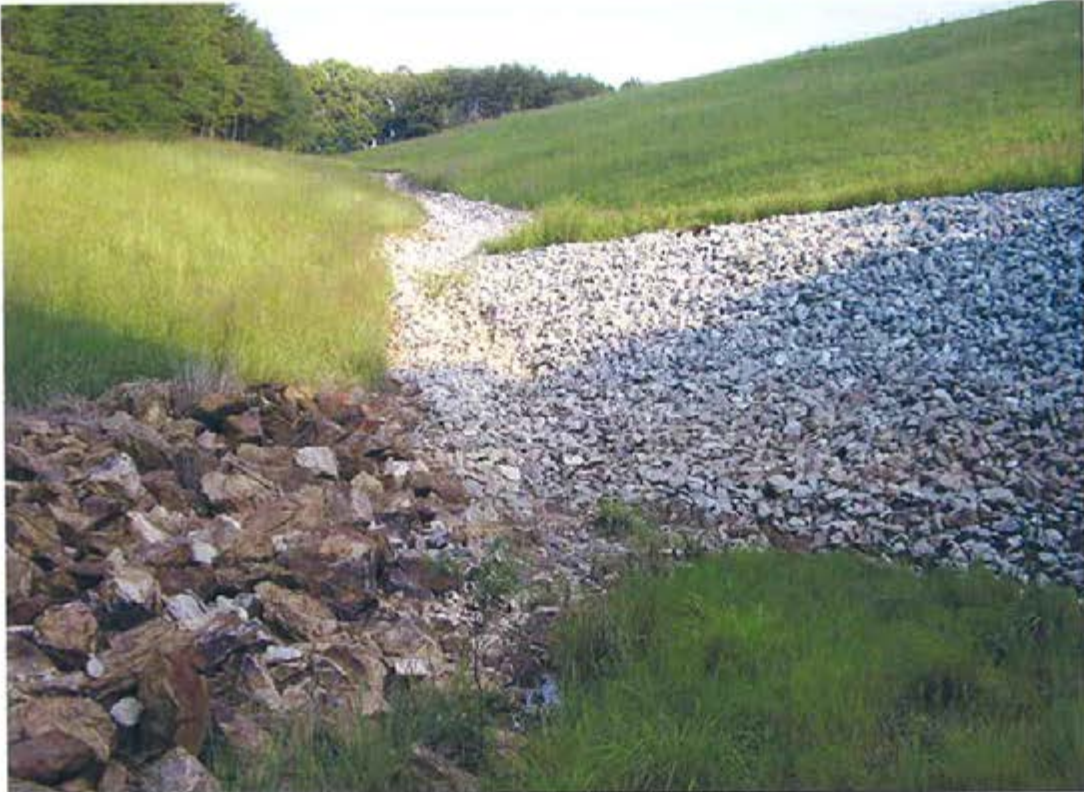
<p>Photograph 4-21A</p> <p>Right abutment rip-rap lined ditch viewed from toe. Note high grass on slope and in pool below toe of rip-rap.</p>

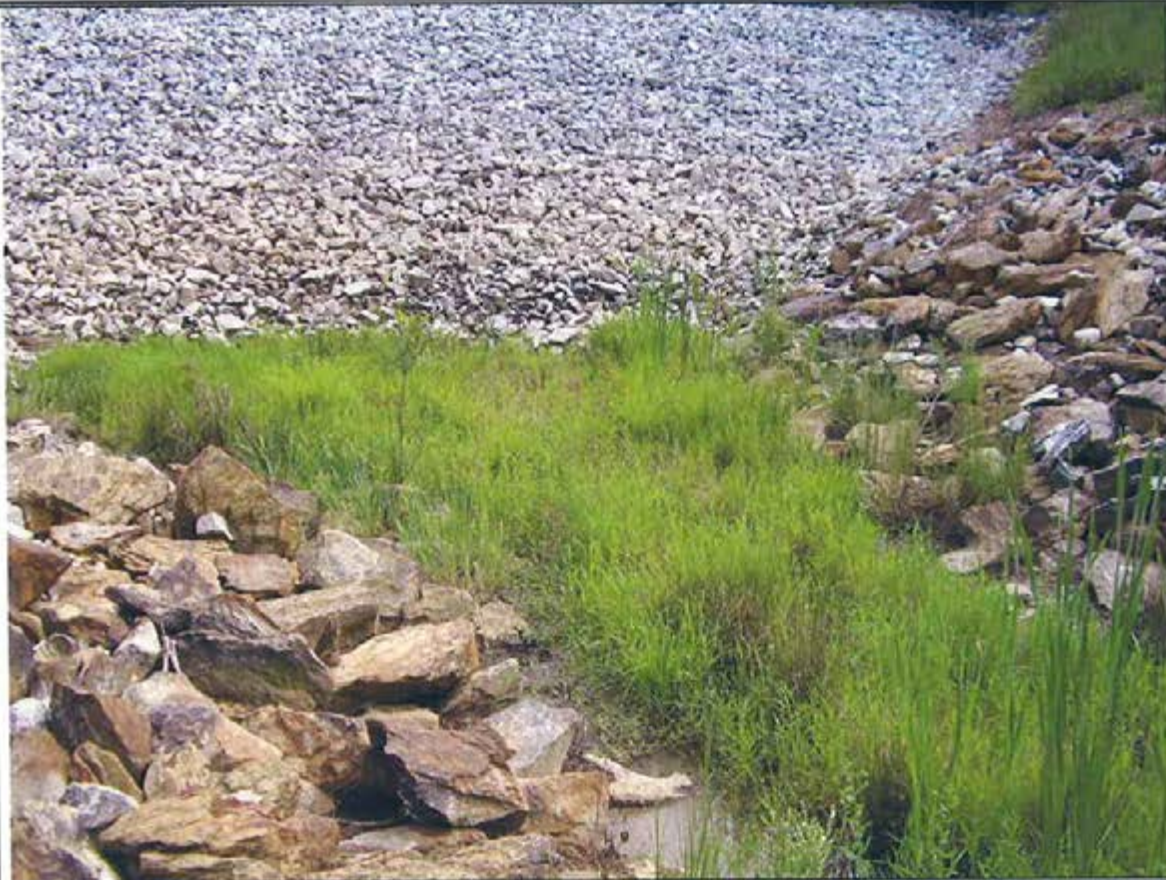
<p>Photograph 4-22</p> <p>As in 2001, seepage emerging from under rip-rap at base of both left and right banks near upstream end of channel shown in Photographs 4-20 and 4-21. Note high grass in bottom of channel.</p>
	Remarks

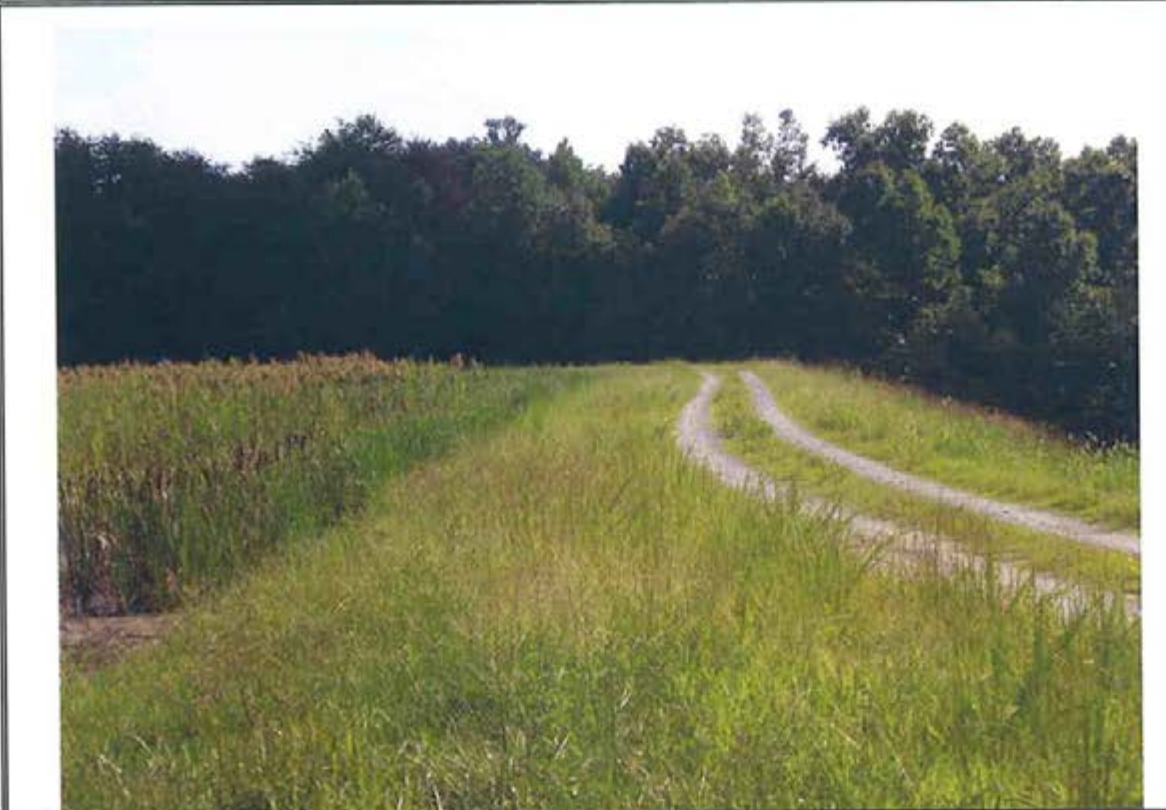
<p>Photograph 4-23</p> <p>Crest of Suck Creek upstream dike (NE to SW view). High grass growth obscures the dike side slopes.</p>

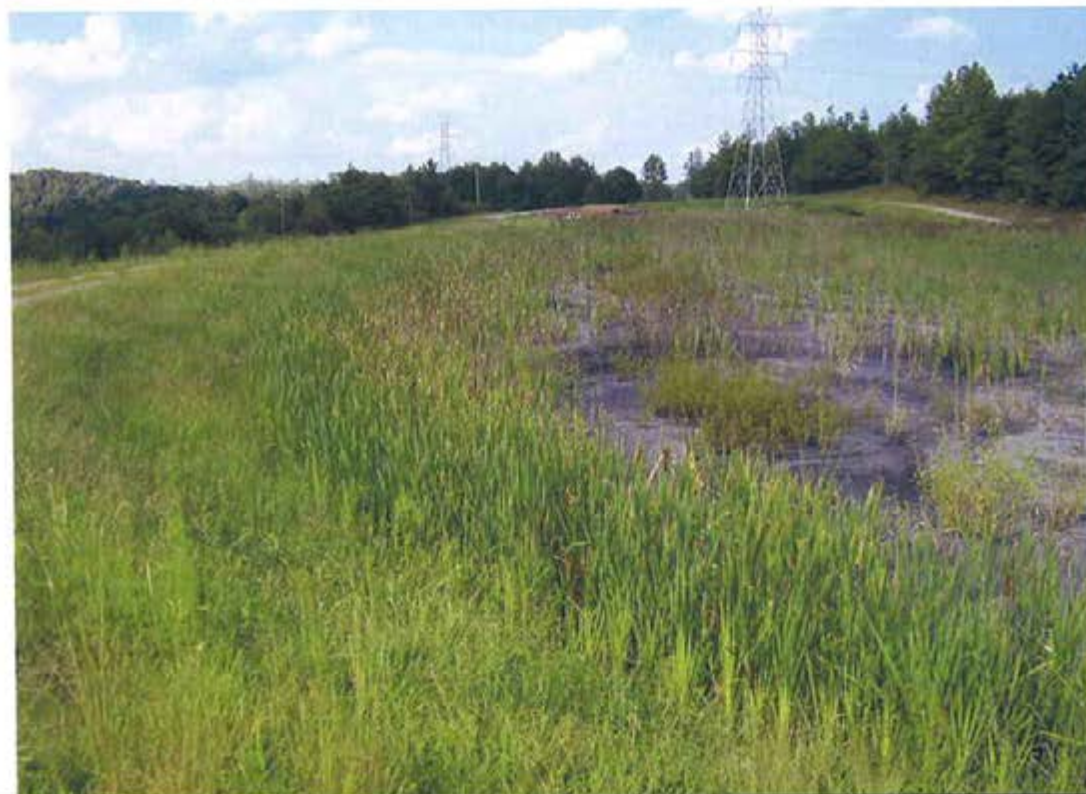
Photograph 4-24

Inside slope of Suck Creek upstream dike (SW to NE view). Slope surface obscured by high grass.

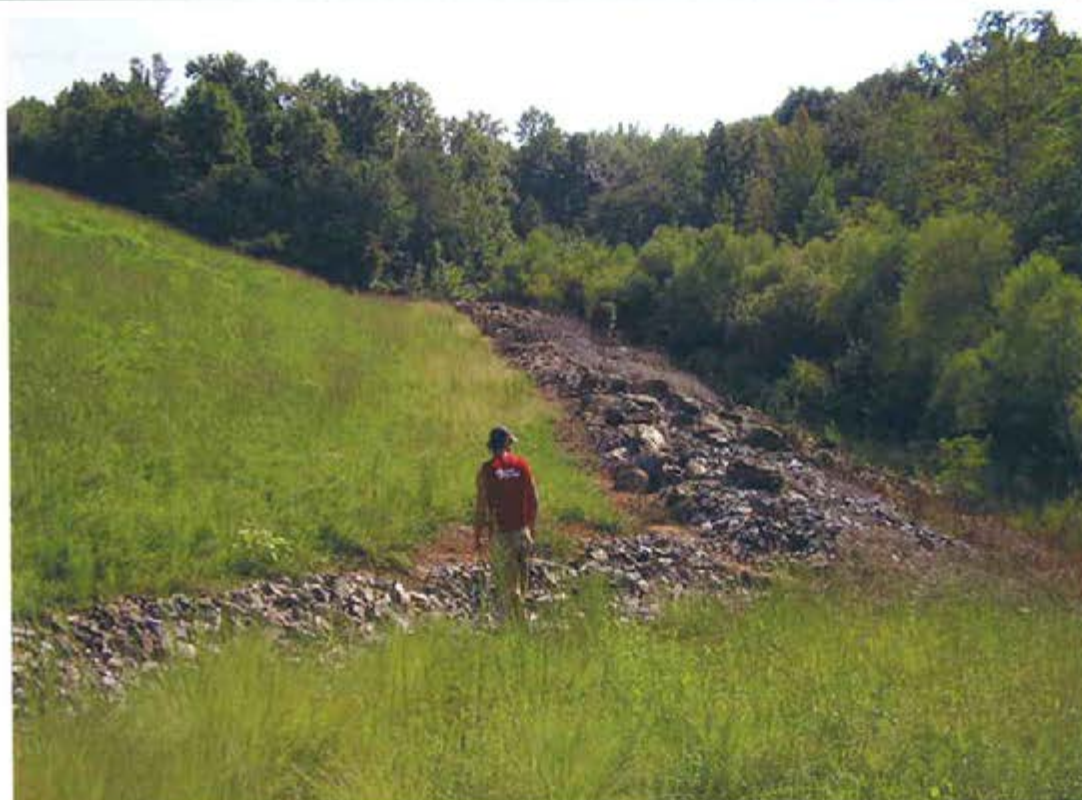
Photograph 4-25

Outside slope of Suck Creek upstream dike (NE to SW view). Area to right of rip-rap lined ditch was wet

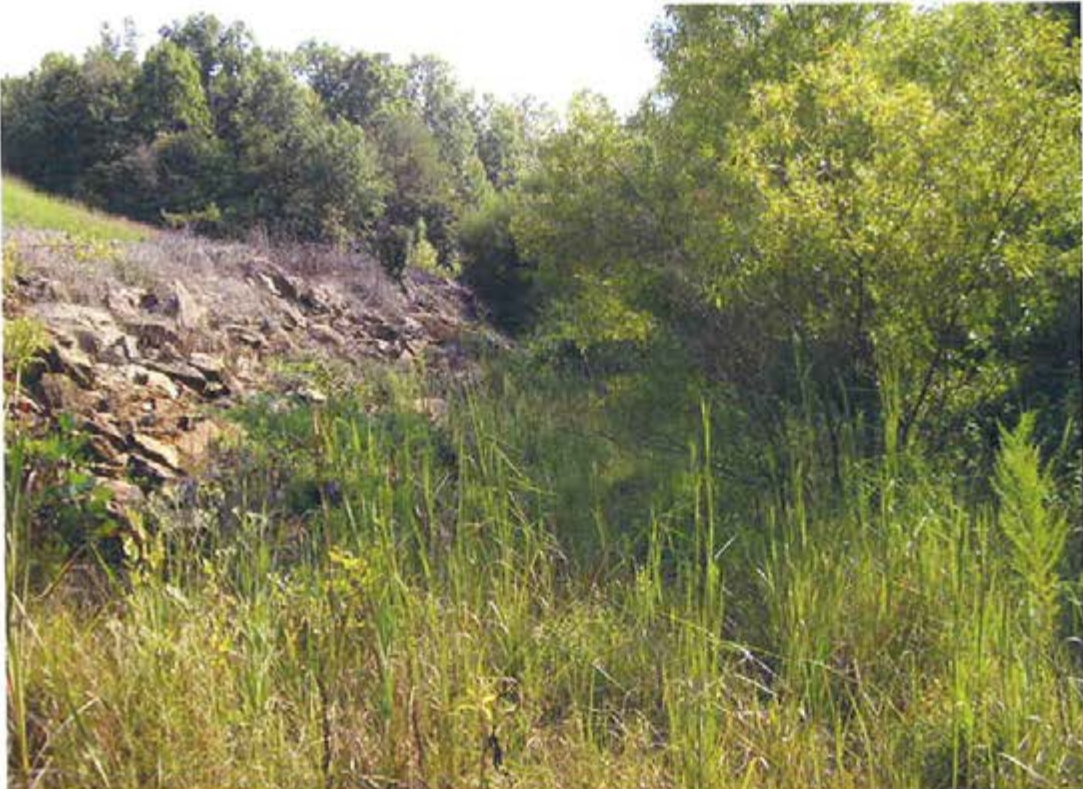
<p>Photograph 4-26</p> <p>Wet area beyond rip-rapped toe of outside slope of Suck Creek upstream dike. In 2001, area had been cleared of vegetation to approximately 15 ft from toe of rip-rap. Vegetation has become re-established within this 15 ft area in 2006.</p>
	Remarks

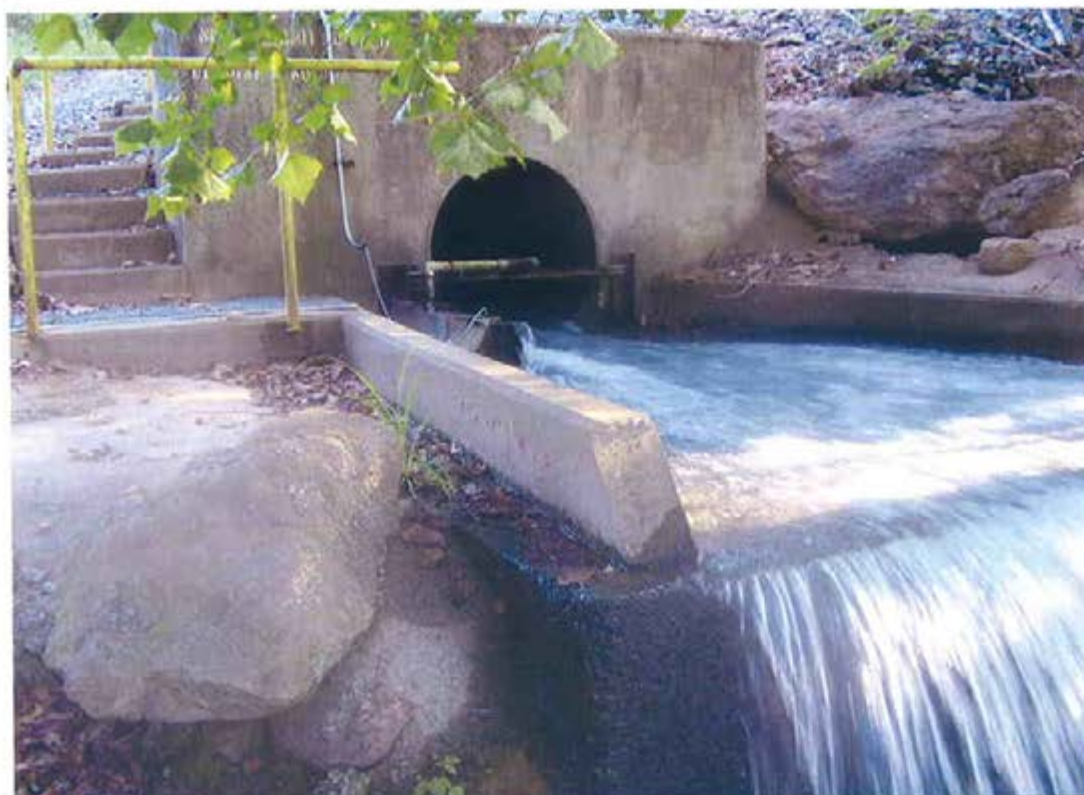
<p>Photograph 4-27</p> <p>View of Suck Creek ash basin drainage tower.</p>

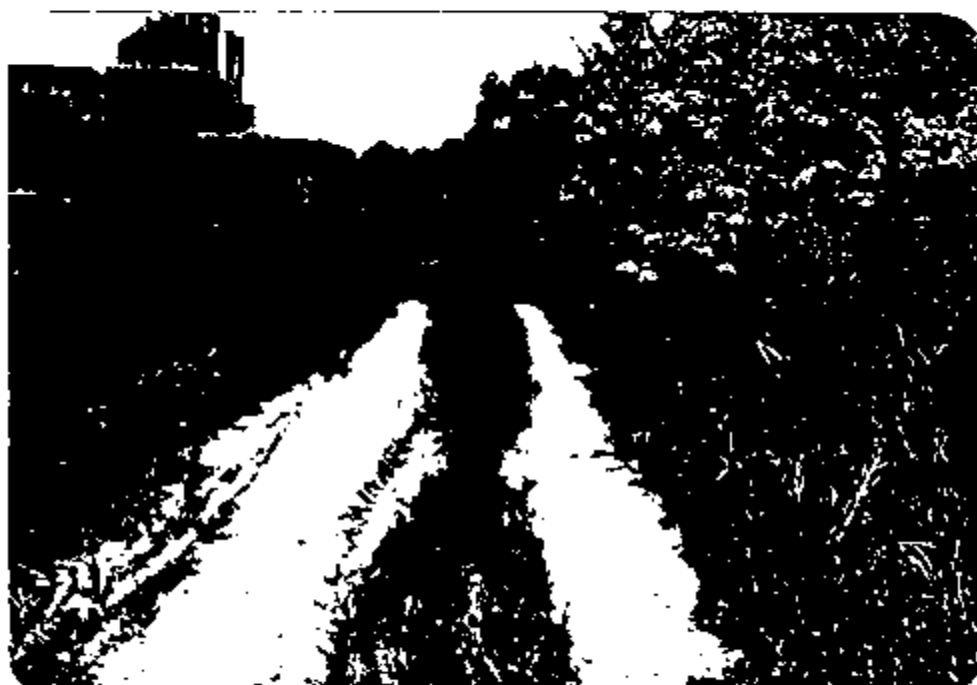
The Units 1-4 old ash retention dike is almost completely overgrown with trees and vegetation. The crest is little more than a rutted trail (Plate 1). The upstream slope and basin area generally are covered with a dense, tall growth of lespedeza grass and weeds (Plate 2), except in the area of the yard drainage holding pond which was nearly empty at the time of inspection (Plate 3). Spoil material from dredging operations at the plant intakes was being pumped into the holding pond, on a temporary basis, at the time of inspection. Mimosa trees (visible in Plates 1, 2 and 3) grow on or overhang much of the dike crest. The downstream slope is heavily overgrown with trees and underbrush, though there is a couple of relatively clear areas (Plate 4). Much of the downstream slope was inaccessible to inspection due to the thick vegetation.

PLATE 1. - CREST OF UNITS 1-4 OLD BASIN DIKE

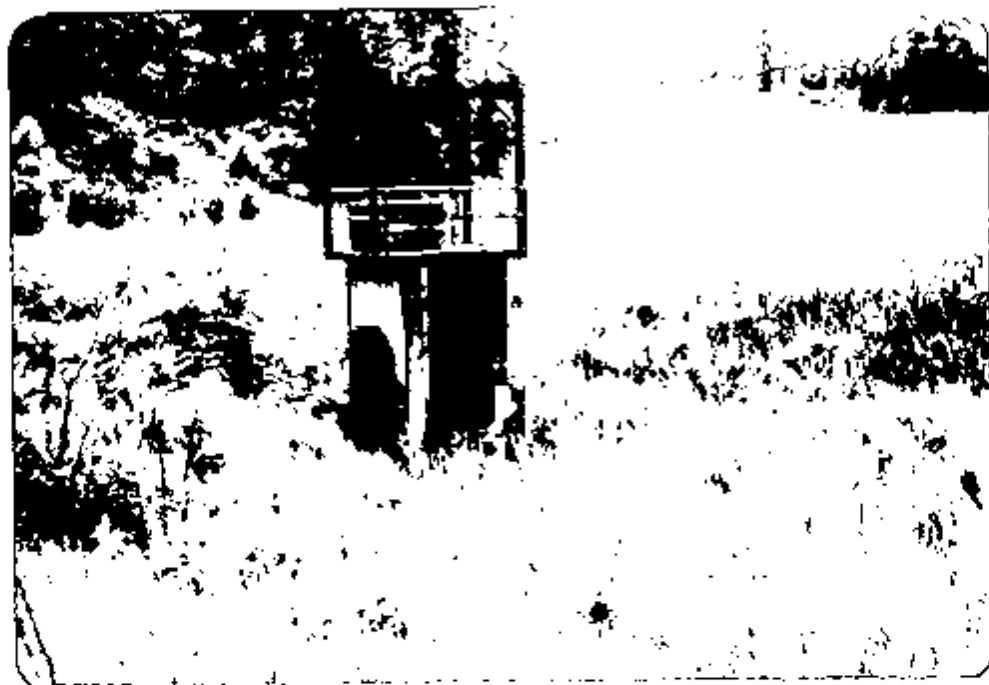
The visible portion of the drainage tower (Plate 7) and the outlet end of the 30-inch diameter corrugated metal bottom discharge pipe (Plate 8) appear to be in fair condition. No seepage, drop-outs or erosion were seen in the embankment over the pipe. There was a small trickle of water flowing from the end of the pipe at the time of inspection.

PLATE 7. - VIEW OF UNITS 1-4 OLD ASH BASIN DRAINAGE TOWER

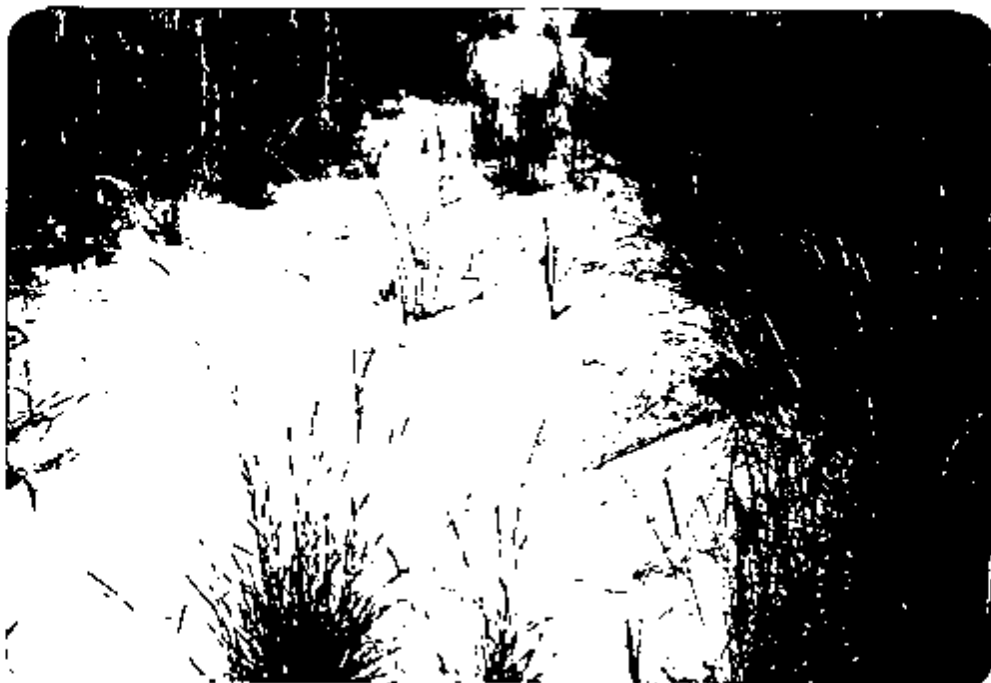
PLATE 17. - SILT ACCUMULATION ON UPPER BERM ON DOWNSTREAM SLOPE
OF SUCK CREEK DOWNSTREAM DIKE

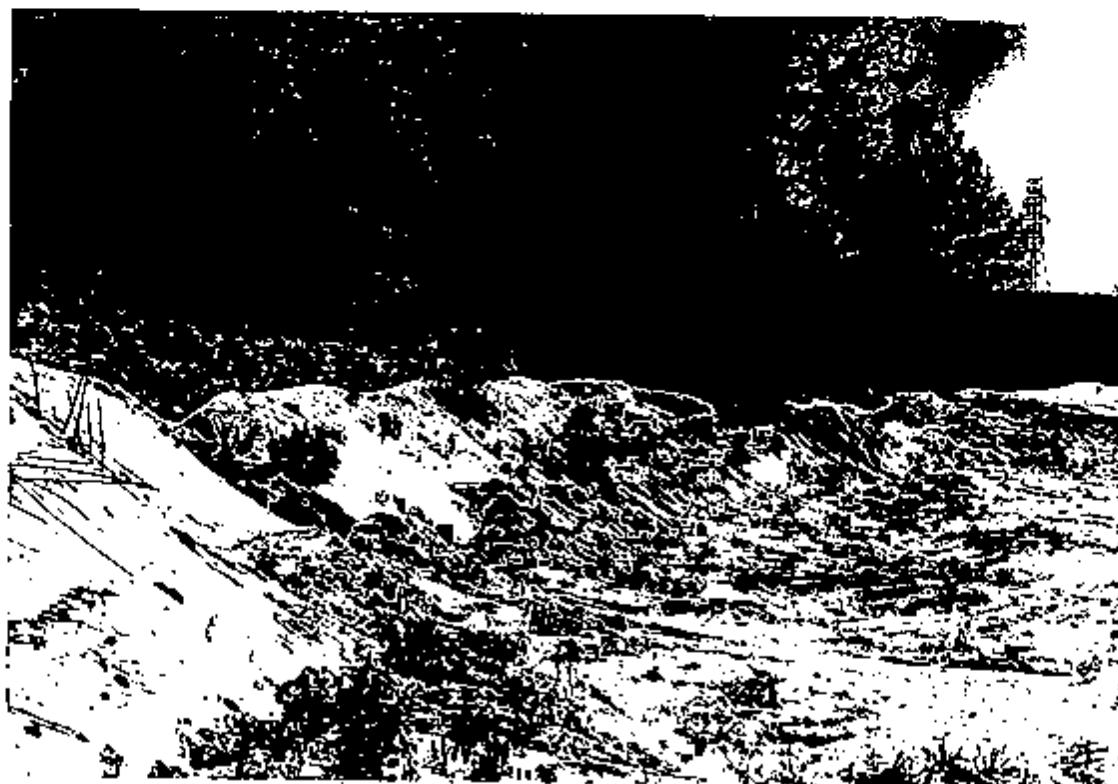
shown in Photo 4-2. Other portions of the upstream slope were observed to be covered with weeds, briars and a few small trees. No signs of slumping or shear failure were observed on this slope. Water levels in the yard drainage holding pond and dredge spoil area were relatively low at the time of inspection as shown in Photo 4-3.

PHOTO 4-2 Inside (Upstream) Slope of Units 1-4 Old Ash Basin Dike (W to E View)

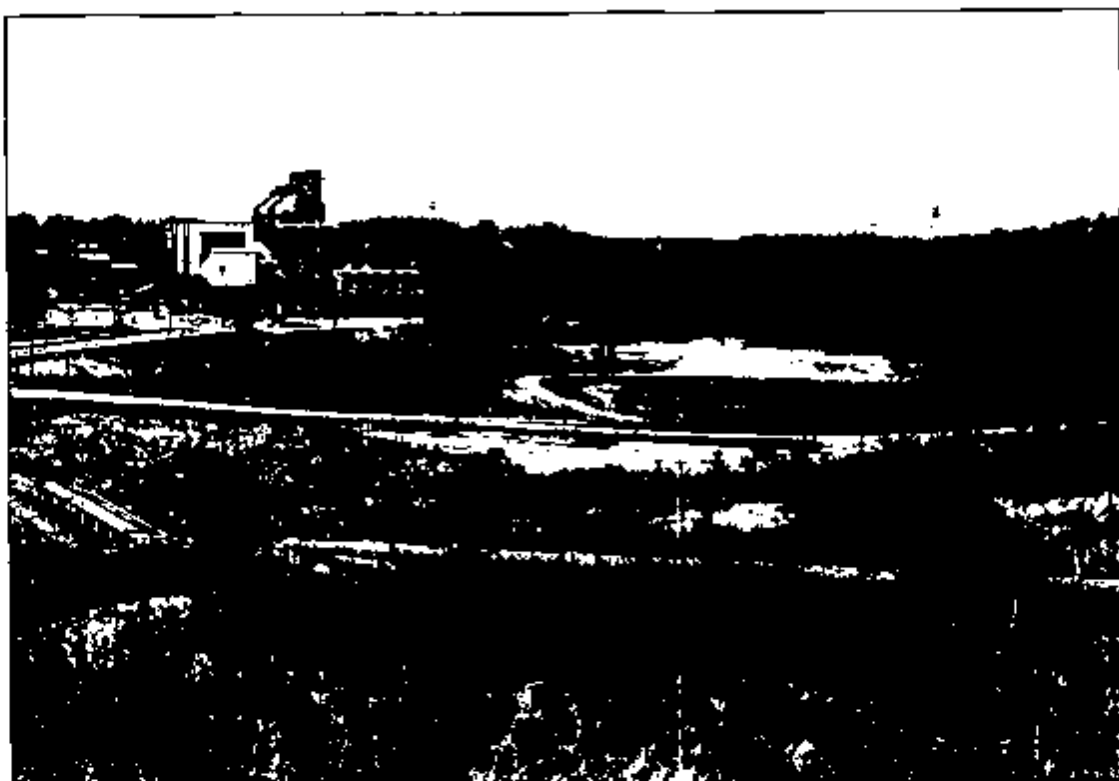
PHOTO 4-3 Yard Drainage Holding Pond and Dredge Spoil Pond in Units 1-4 Old Ash Basin Area

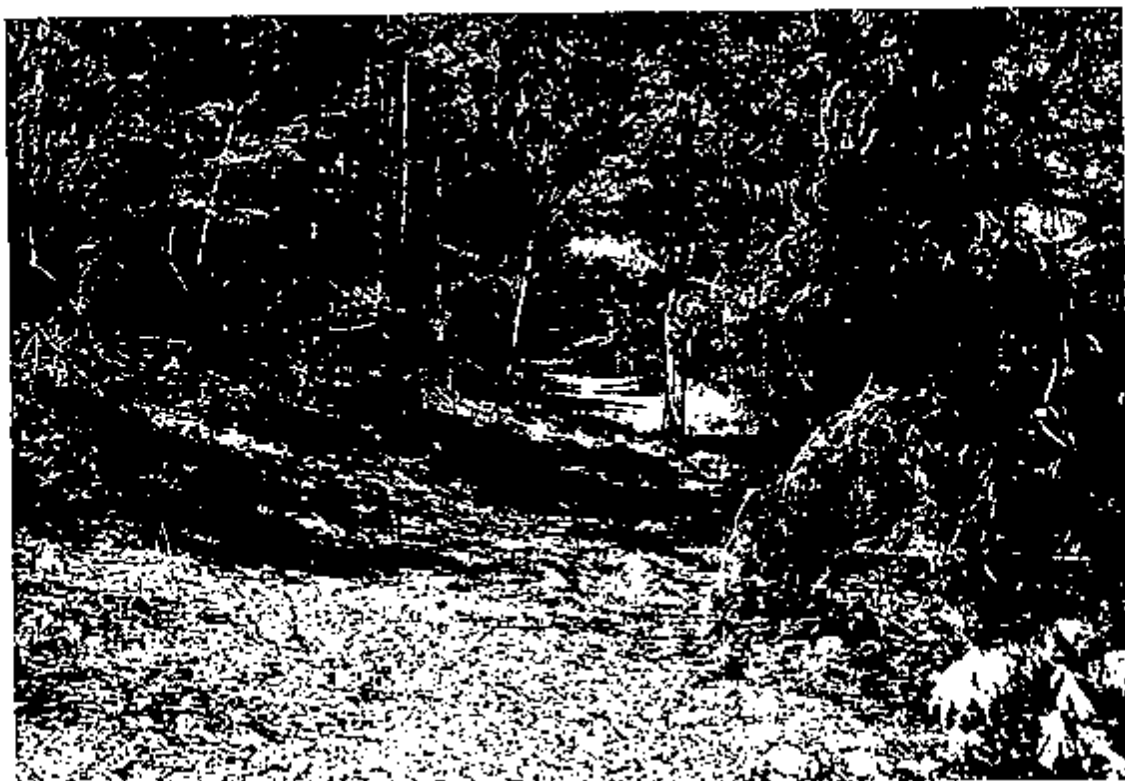
A typical view of the wooded outside (downstream) slope of the Units 1-4 ash basin dike is shown in Photo 4-4, and the cleared inspection trail located along the toe of this slope is shown in Photo 4-5. No seepage outcrops were seen on the slope above the toe, and no obvious signs of slope failure or active erosion were seen on the slope, though inspection was somewhat hampered by the vegetation.

PHOTO 4-5 Trail Along Toe of Outside Slope of Units 1-4
Old Ash Basin Dike (E to W View, Slope to Left)

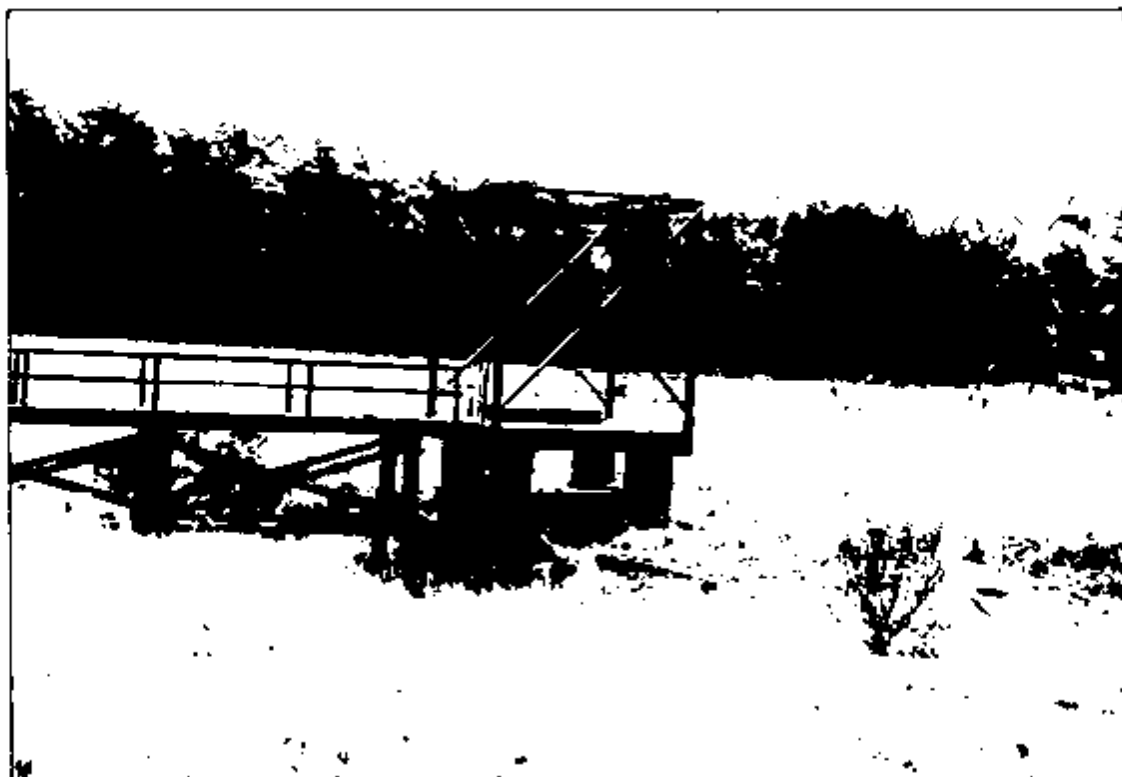
The visible part of the Unit 5 retired ash basin drainage tower is shown in Photo 4-13; the structure was observed to be in good condition. The outlet end of the 60-inch diameter RCP outlet is shown in Photo 4-14. There appeared to be some spalling along the invert of the pipe, but otherwise the pipe was in good visual condition.

PHOTO 4-13 View of Unit 5 Retired Ash Basin Drainage Tower

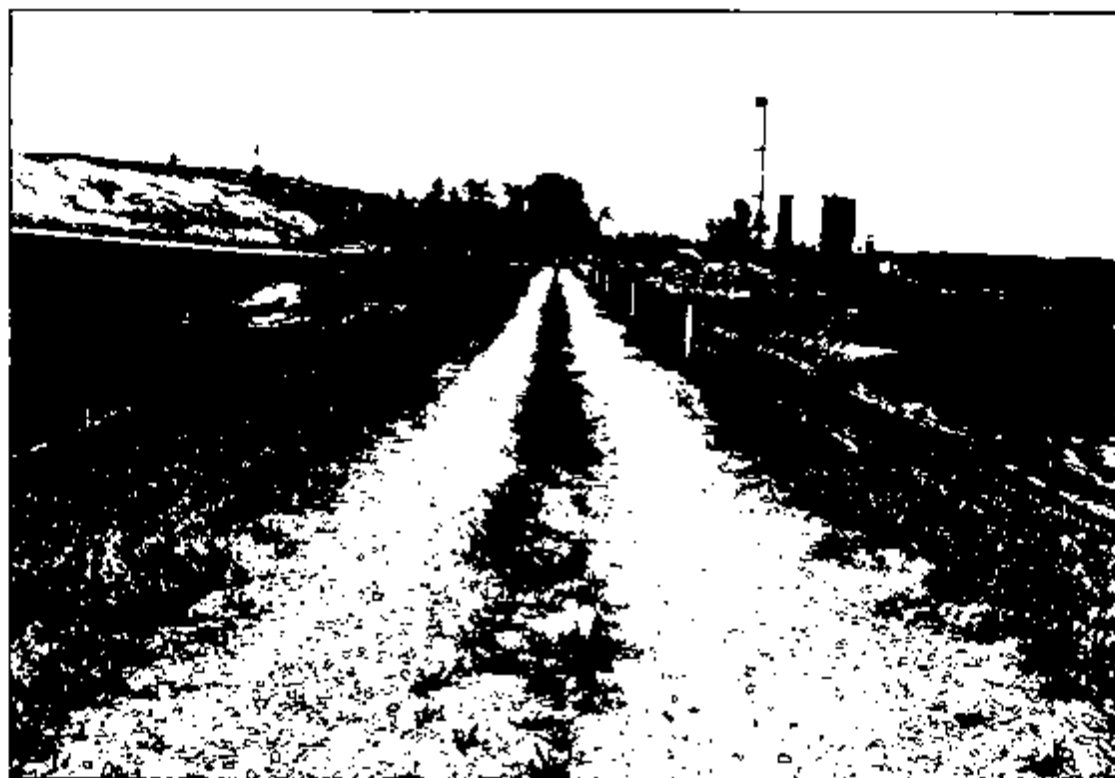
The crest of the downstream dike of the Suck Creek ash basin was observed to be in good condition with no visible tension cracks, major depressions, sags or other signs of shear failure or excessive settlement; a view of the crest is shown in Photo 4-15.

PHOTO 4-15 Crest of Suck Creek Downstream Dike (E to W View)

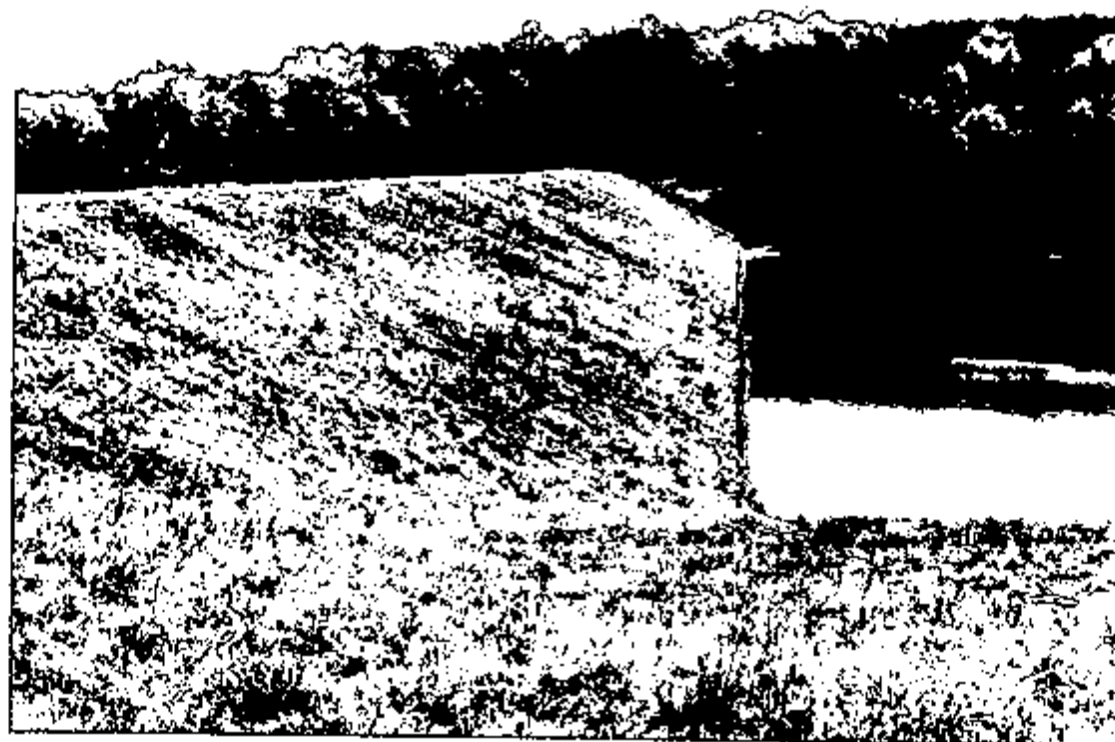
The inside slope of the downstream dike was observed to be in good condition with a well maintained grass cover as shown in Photo 4-16. There were no signs of shear failure or major erosion on this slope. The riprapped-lined intercept ditches at the abutment contacts were in good visual condition.

PHOTO 4-16 Inside Slope of Suck Creek Downstream Dike
(W to E View)

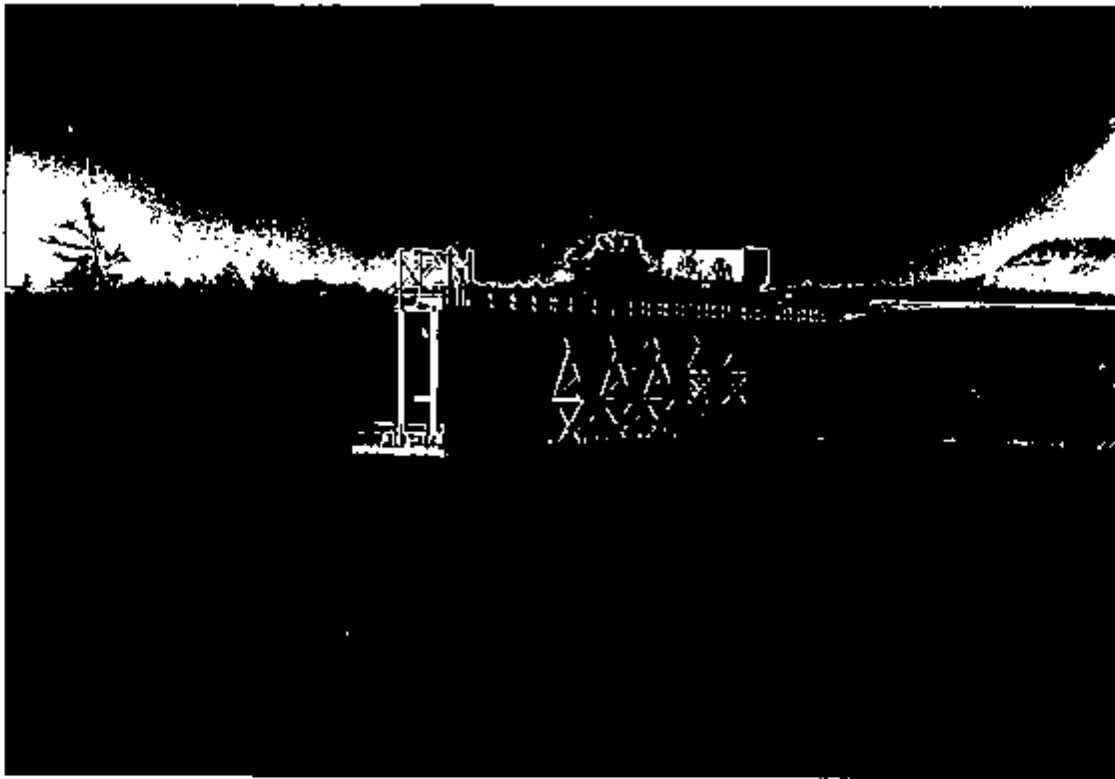
The visible part of the drainage tower is shown in Photo 4-29, and the outlet end of the 42-inch diameter reinforced concrete bottom discharge pipe is shown in Photo 4-30. These structures were observed to be in good condition. Discharge from the pipe was clear, and no dropouts or sinkholes were observed in the soils over the buried outlet pipe. No seepage was observed around the outside of the pipe at the outlet end.

PHOTO 4-29 View of Suck Creek Ash Basin Drainage Tower

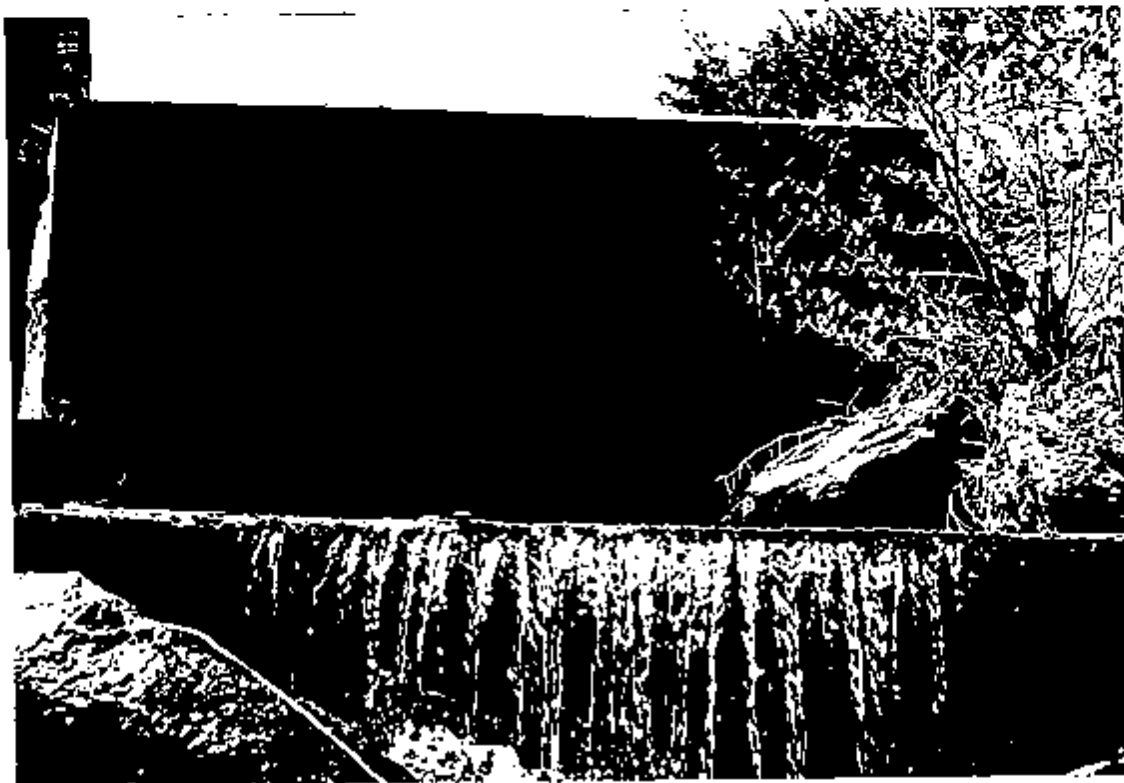
PHOTO 4-30 Outlet End of 42-Inch RCP Outlet for Suck Creek Ash Basin
